STRUCTURES NOTE 461

**STRUCTURAL DESIGN OF BFRP PATCHES FOR
MIRAGE WING REPAIR**

JULY 1980

DEPARTMENT OF DEFENCE
DEFENCE SCIENCE AND TECHNOLOGY ORGANISATION
AERONAUTICAL RESEARCH LABORATORIES

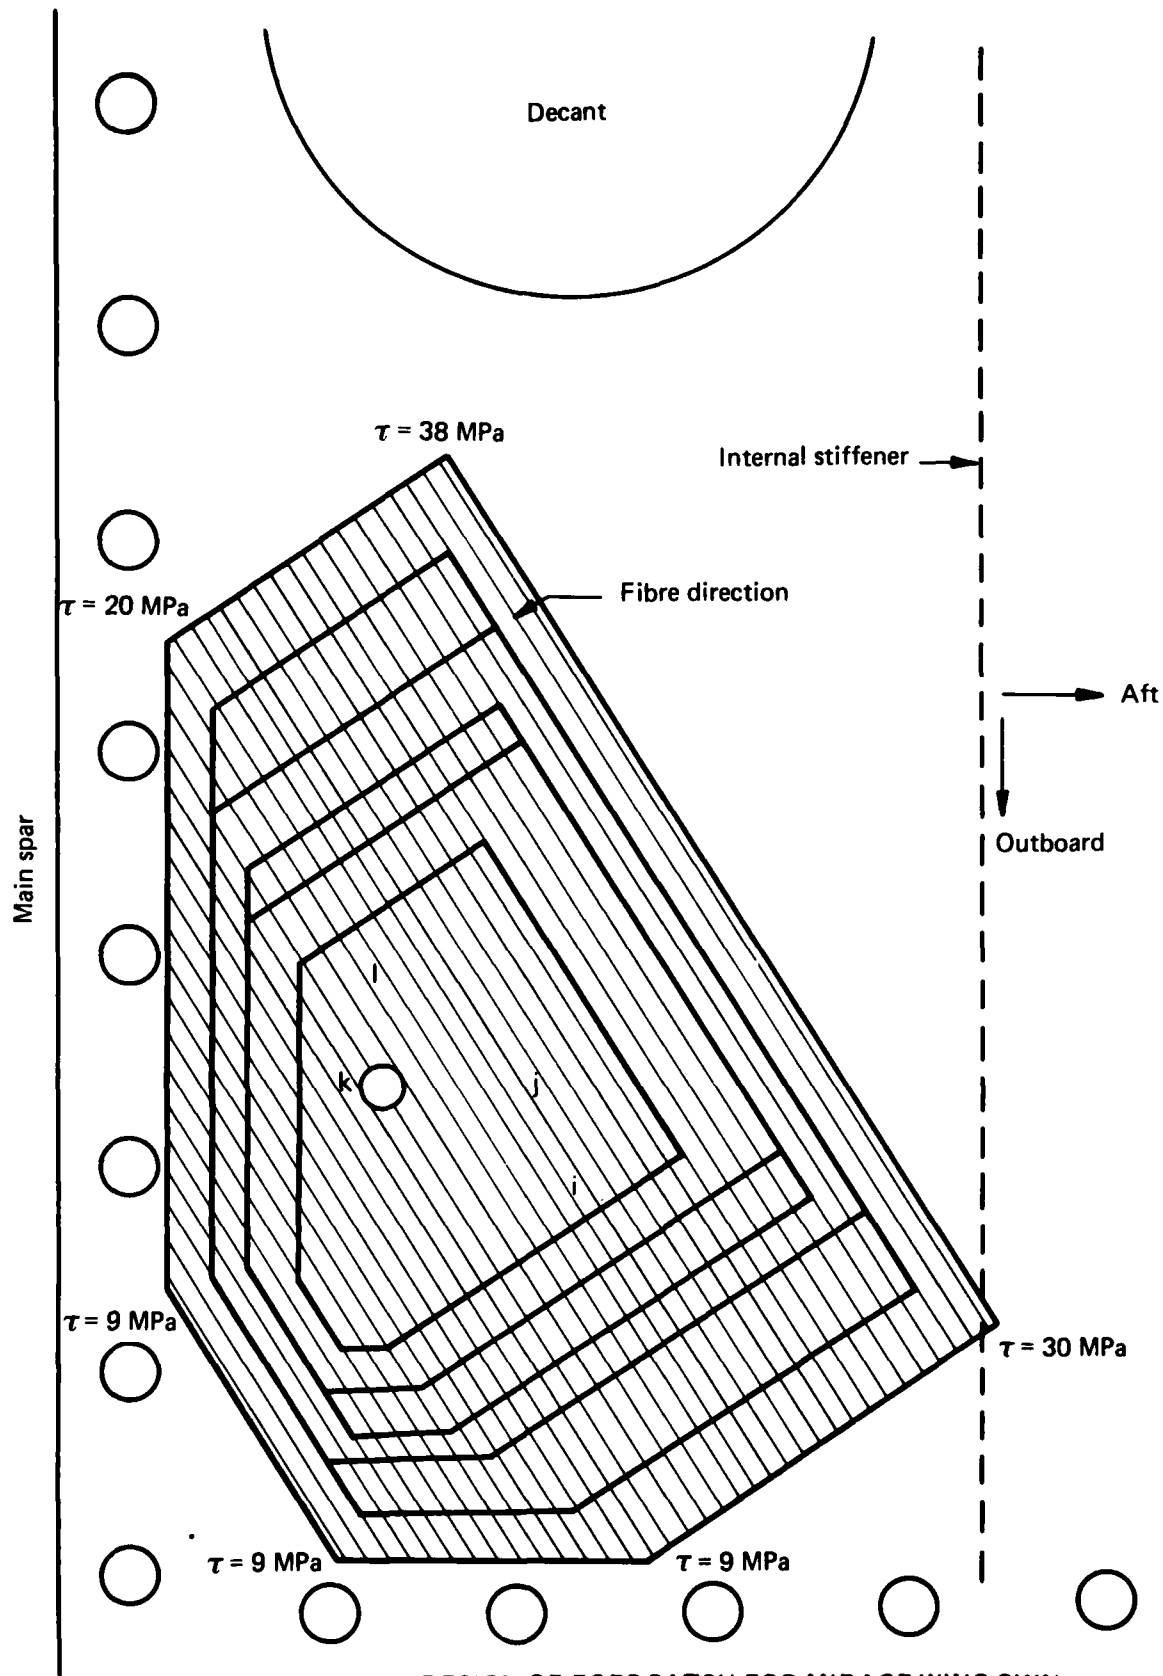
FIG. 3 INITIAL A.R.L. DESIGN OF FGRP PATCH FOR MIRAGE WING SKIN (Full Scale)

The geometry of the initial patch design is shown in Figure 3. The patch consists of a uniaxial BFRP laminate with the fibres at a direction of 33 degrees to the spar, i.e. in the direction of the maximum principal tensile stress. The patch is stepped in the thickness from one ply to six plies as shown in Figure 3. (A single ply of BFRP is approximately 0.125 mm thick).

Let us now examine the effect of patch number 1 in more detail. The shear stress distribution in the adhesive along the edges of this patch is shown in Figure 3. As mentioned earlier these stresses are significantly below the levels at which fatigue damage occurs in the adhesive. As a result it is unlikely that the patch will debond from the wing skin. The reductions in the maximum principal stresses and the maximum principal strains in the wing skin at locations *i*, *j*, *k* and *l*, as shown in Figure 3, are given in Table 3.

Even at limit load we see that in all of the patches the adhesive shear stress is below the value of 45 MPa and as a result at no stage should fatigue damage occur in the adhesive. We also see that of the five patches considered the two unidirectional patches (numbers 1 and 4) of thickness 0.762 mm best reduce the maximum stress σ_1 at the fairing hole and at the two rivet holes. Indeed they both reduce stress fields in the vicinity of the holes to values similar to the stress field at the reference point B. Of these two patches, patch 4 is at first glance the most desirable since the maximum stress developed in the fibres in patch 4 is almost half that developed in patch 1. This is due to the fact that patch 4 contains no hole and, as a result, does not allow for attachment of the fairing at this point. However, since at limit load the maximum stresses in patch 1 result in a fibre strain of 0.004, which is below the maximum permissible working strain of 0.005, and since the RAAF wished to retain the fairing attachment hole, patch number 4 was rejected. The patch finally decided upon was therefore patch number 1.

Summarising these results we find that the unidirectional boron fibre patch of thickness 0.762 mm adequately satisfies all of the design requirements and in addition, as required by the RAAF, still allows for the fairing attachment hole to be retained.
